TECHNICAL DIAGNOSTICS OF HYDROPOWER TURBINE USING MODERN MEASUREMENT TECHNIQUES

Grzegorz ŻYWICA¹, Maciej KANIECKI²

Summary

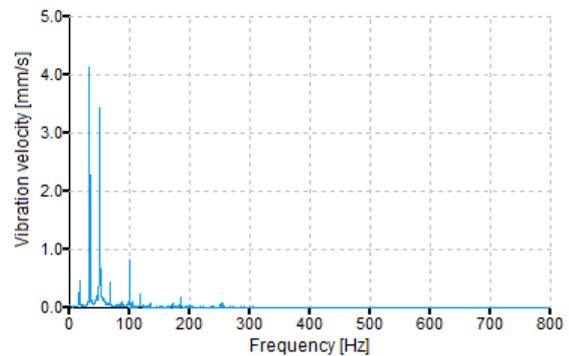
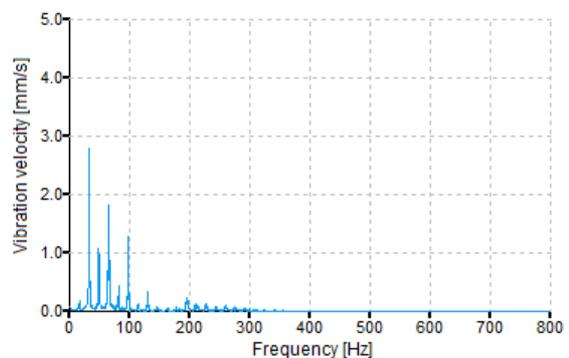
The vibration spectra for two selected measuring points, obtained during dynamic performance test are presented in Fig. 3 and 4. The dominant frequency component of 33.5 Hz is present in both signals, which is close to the frequency value corresponding to misalignment or bending of the shafts. High vibration level was also registered at 50.5 Hz. Moreover, the elevated vibration level in the vertical direction was observed at 65 Hz. Furthermore, the frequency component of 100 Hz was clearly apparent, which corresponds to the electrical excitation frequency of the generator.

Fig. 3. Frequency spectrum of the vibration velocity at node II in the direction X.

Fig. 4. Frequency spectrum of the vibration velocity at node II in the direction Y.

It is also worth noting that the synchronous frequency component (about 16,5 Hz) had very low amplitude value, and this was an indication of correct balance of the rotating system. On the basis

of conducted signal analysis it can be concluded that the exceeded vibration level is caused by shaft misalignment or deflection.

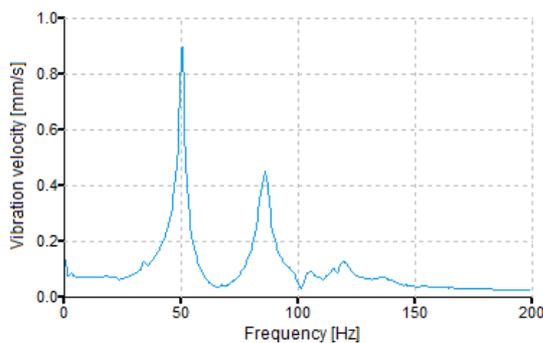
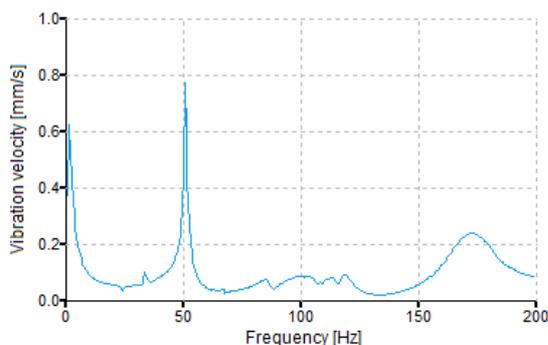
Fig. 5. Vibration spectrum after impact excitation at the node no. I (direction X).

Fig. 6. Vibration spectrum after impact excitation at the node no. II (direction X).

On the basis of characteristics obtained it can be explicitly stated that the generator oscillated about its horizontal plane at the frequency of 50.5 Hz. In view of the fact that at the same frequency high vibration level was observed for two measuring nodes it has been found that these vibrations can be classified as mechanical oscillations of the entire generator. The resonance also occurred in the node I at 86 Hz, which was related to eigenvibrations of the rear part of generator (also in the horizontal plane). An attempt was also undertaken to determine other mode shapes of the hydro set but the obtained results did not allow for unequivocal identification of remaining eigenfrequencies.

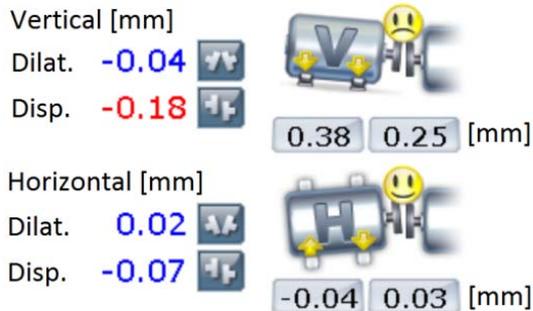
The shaft alignment check revealed the exceedance of limit values in the vertical plane. The height difference between two coupling parts was

only around 0.18 mm, meaning that a change in the heights of front and rear generator's terminals must be applied. These heights were adjusted by 0.25 mm and 0.38 mm, respectively (Fig. 8). Other values were within the recommended tolerances.

Fig. 8. Shaft alignment check results (screen from the measuring instrument).

To confirm the obtained results, the shaft alignment process was repeated several times for various angular positions of the shafts and places for fixing the measuring device. The subsequent results were very close to each other and to the results presented in Fig. 8. The generator was lowered down by removing the spacers of appropriate thickness from under its terminals.

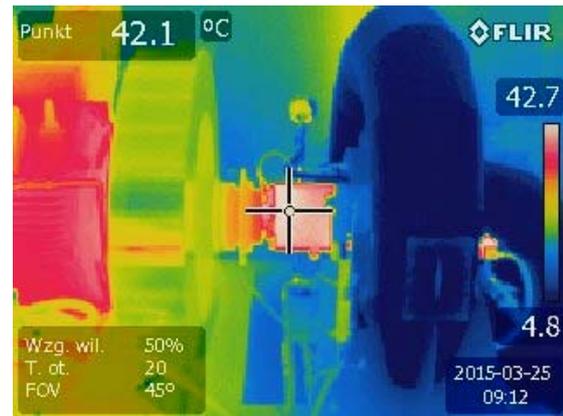
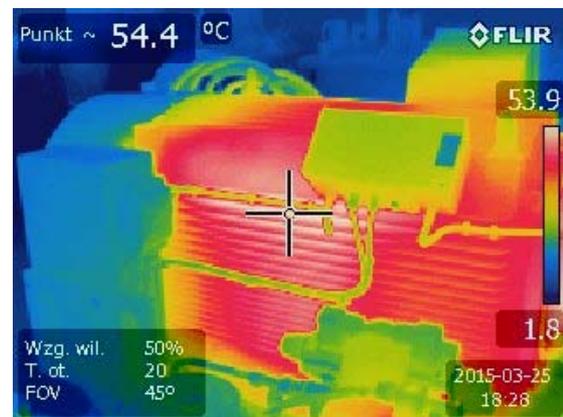
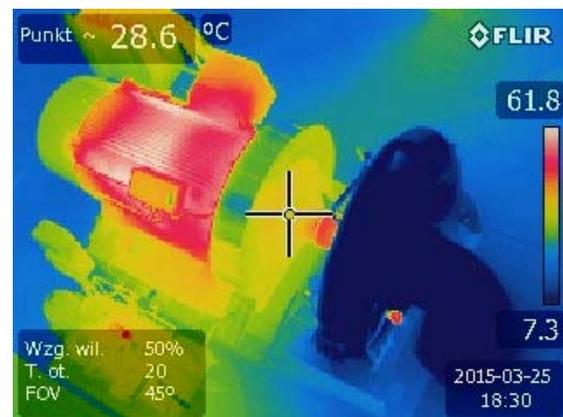
The selected results of the machine's thermographic analyses are shown in Fig. 9 - Fig. 11. In general, all temperature levels of hydro set looked good. The outer surface of the electro-generator's body reached up to 62 °C in some places and the turbine's bearing housing temperature reached a maximum of 65 °C. However, the biggest interest was aroused by the large temperature difference between the turbine and generator bodies (up to 55 °C). This can be seen in Fig. 11. In view of this information, it can be said that such a large temperature difference between bodies and bearing supports attached to the shafts should be addressed in the alignment process. Thermal expansion of steel parts, in that case, may cause the mutual displacement of the shafts in opposite directions, thus worsening operating conditions of the rotating system which leads to the occurrence of higher vibration level.

Fig. 9. Outside surface temperature of the turbine body at the point of bearing attachment.

Fig. 10. The temperature distribution on the outer surface of the generator (from electrical connection side).

Fig. 11. Outside surface temperature of the hydro set (top view).

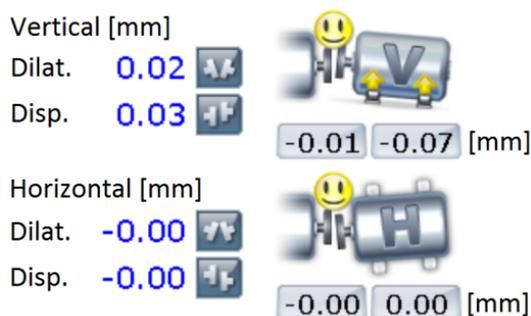
Fig. 12. The results of shaft alignment check after the adjustment of generator's position (screen of the measuring instrument).

The conducted measurements showed correct mutual positions of the shafts. The obtained deviation from ideal position in the vertical plane reached several dozen μm , which did not permit further correction of the position.

In the described case, the first way was used, i.e. the control measurements were carried out for the pre-heated machine. Regarding the initial position, the spacers with a total thickness of 0.4 mm were removed from under rear generator's terminals, and the spacer of the thickness of 0.2 mm from under front generator's terminals. The results of shaft alignment check obtained after the above changes are shown in Fig. 12.

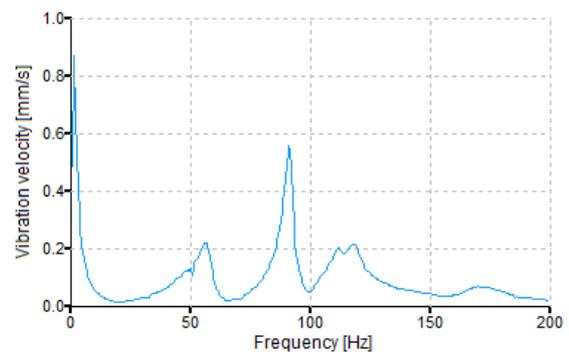
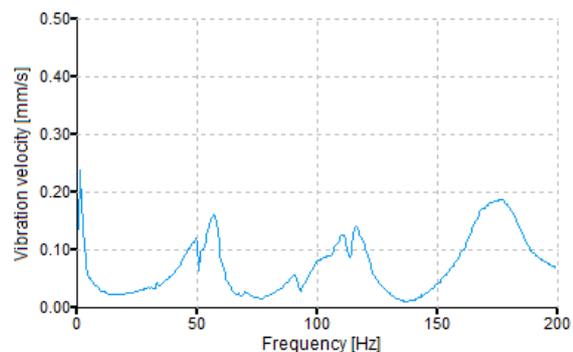
Fig. 13. Vibration spectrum after the impact excitation at node I (direction X).

Fig. 14. Vibration spectrum after the impact excitation at node I (direction Y).

At the characteristic frequency of 50.5 Hz, the elevated vibration level continued to be observed, but it was no longer seen as a resonance.

The additional elements increasing the stiffness of the generator's foundation were mounted on the steel frame to change the frequency of generator's eigenvibration. The aim was to increase the natural frequency enough to prevent overlapping it with the exciting frequency of the rotating system $3X$, coming from misalignment. After mounting the frame reinforcements, the registered generator's vibration spectrum (Fig. 13 and Fig. 14) showed that the eigenfrequency increased to 55.5 Hz (was higher by 5 Hz than it had been before). This avoided the problem of operation under resonance conditions. Moreover, the vibration amplitude value of this mode shape was more than three times lower, at a similar level of exciting force.

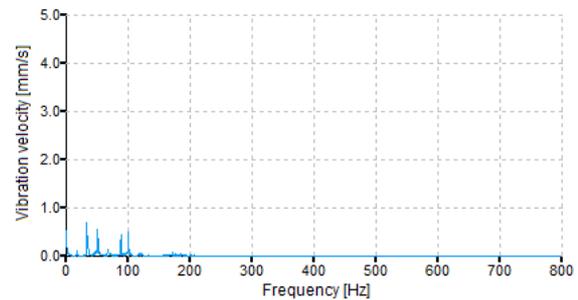
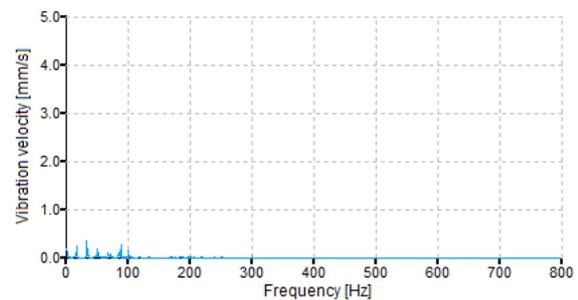
In line with a decrease in vibration level, the frequency spectra of measured signals changed (Fig. 15 and Fig. 16). Apart from a large decrease in the amplitude values of individual vibration components (compared to the results obtained during initial check, see Fig. 3 and Fig. 4), the reduction of the prevailing importance of characteristic components occurring during misalignment of the shafts could be observed. The characteristics below contain several vibration components of comparable amplitude values, which means that the overall vibration level

Fig. 15. Frequency spectrum of the vibration velocity at node II in the direction X

Fig. 16. Frequency spectrum of the vibration velocity at node II in the direction Y.
