## INDUCTION MOTOR DIAGNOSIS WITH USE OF ELECTRIC PARAMETERS

Krzysztof ROCZEK, Tomasz ROGALA

### Abstract

Keywords: induction motor, MCSA, current spectrum, frequency inverter

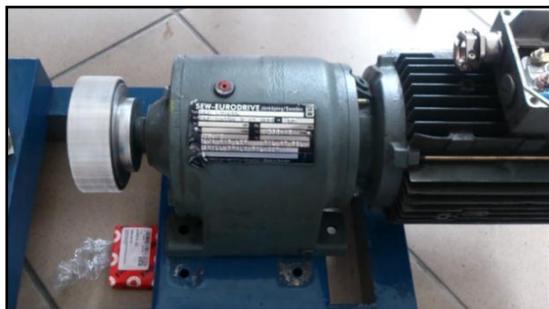
Fig. 5. Laboratory stand 2

Figures 4 and 5 present motors that were tested during complete laboratory experiment. Figures 6 and 7 presents also measurements system, which will be also in use in industry- National Instruments

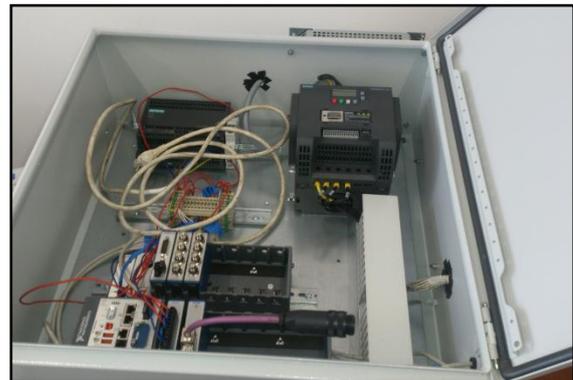
Fig. 6. Measurement system with frequency inverter

RIO and Allen Bradley controller (Logix55LSP). During the experiment the current transducers (LEM HAS 50-S) were applied to measure input current of three phase motors. The motors were supplied from frequency inverter Sinamics V20 V20 230V/400V, 3kW. The measurement data were read by National Instruments RIO module and stored on external flash memory. Additionally, during experiment PLC was configured. Data transmission was established with the use of DeviceNet interface due to the fact that it is planned to startup this diagnosis system on a real industrial object with Allen Bradley controller.

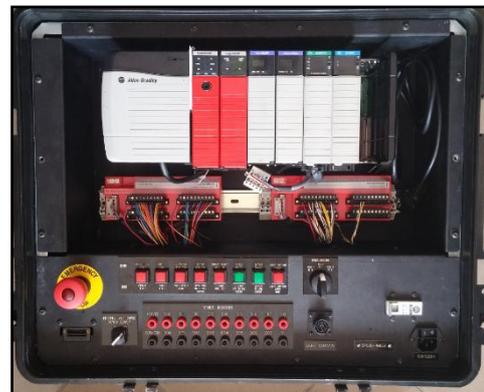
Fig. 7. Box with Allen Bradley PLC

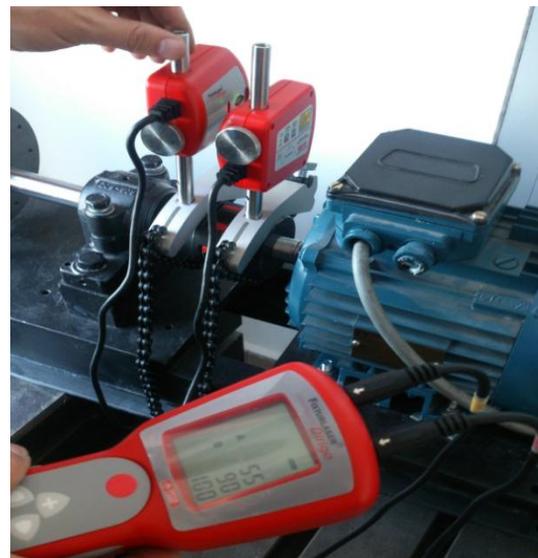
Fig. 9. Alignment adjustment with use of Dirigo Fixture Laser tool

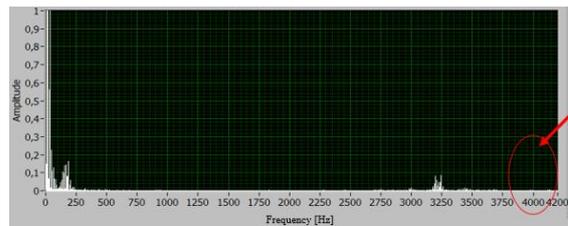
Fig. 18. Reduced pulse frequency of inverter

Figure 17 shows also sidebands around fundamental frequency that are identified as slip stripes. As in the previous case, the pulse frequency was significantly reduced by frequency inverter due to high load of the system (shown if figure 18). One may recall that the nominal current of motor was on a level of 3 A and the measured current was nearly 4 times higher.
