EXPERIMENTAL INVESTIGATIONS OF SURFACE WEAR BY DRY SLIDING AND INDUCED DAMAGE OF MEDIUM CARBON STEEL

Abstract

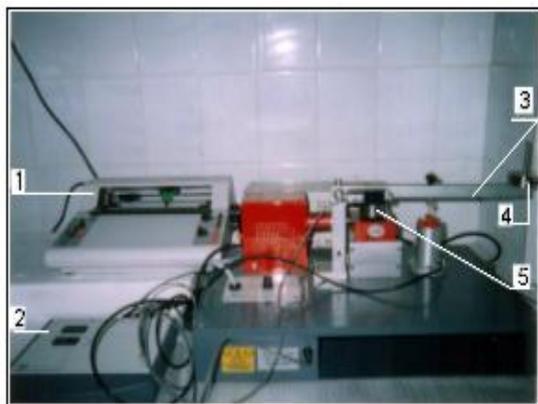
Fig. 1. Tribometer type TE91: 1 - recorder; 2 - display box; 3 - load lever; 4 - applied load; 5 - disc

The dry sliding wear tests were carried out in air at room temperature, of about $25 \pm 2^\circ\text{C}$, using a tribometer (pin on disc system) type TE91 as shown in figure 1. It is based on the principle of the wear machine by sliding. The pin is secured in a hole with a locking screw on an aluminium load arm. It is loaded against a disc by masses of varying weight. The disc is fixed on a support and rotates at varying rotational speeds.

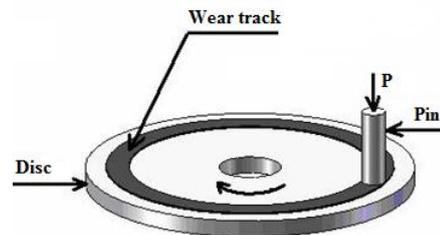
Fig. 2. Pin-disc contact

Figure 2 shows the contact between the pin and the disc and the resulting wear track.

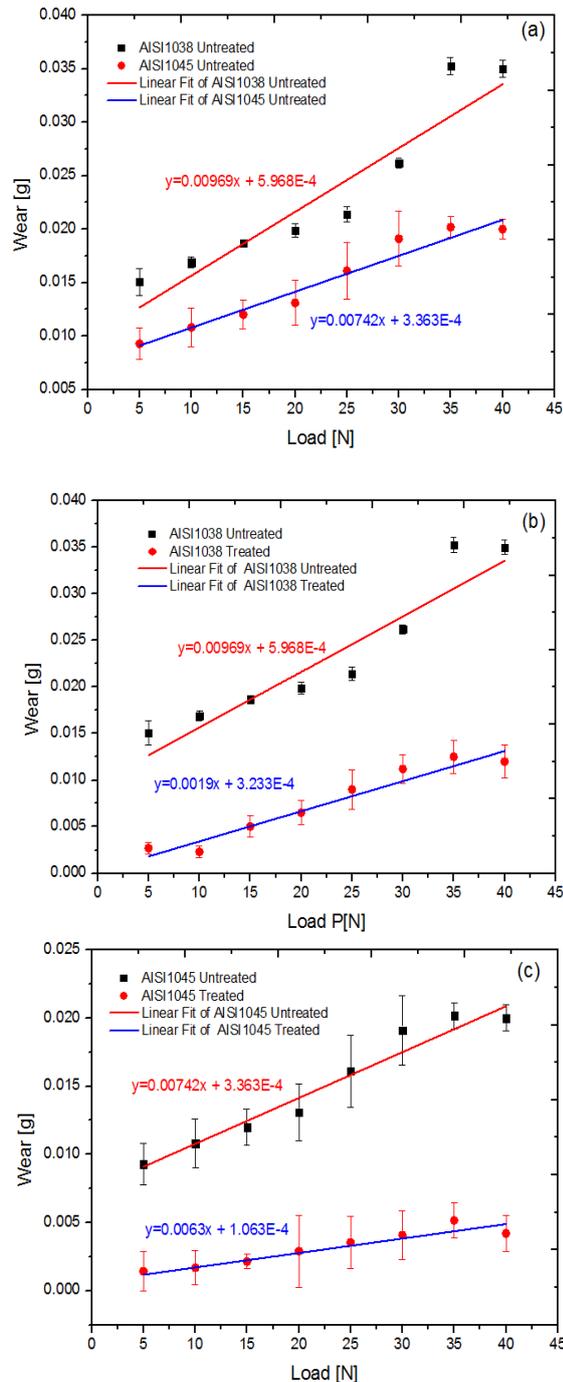
Fig. 3. Variation of wear of untreated and treated pins as a function of the normal load P

Figure 3 shows that the variation in pin wear is a linear function with the normal load P applied.

The untreated AISI 1038 pin generally shows a high mass loss compared to the untreated AISI 1045 pin (fig. 3a).

The AISI 1038 and AISI 1045 treated pins indicate a lower mass loss than the untreated pins (Fig. 3b and 3c).

The four pins (AISI 1038 and AISI 1045 untreated and treated), reveals that the treated AISI 1045 pin shows the smallest loss in mass.

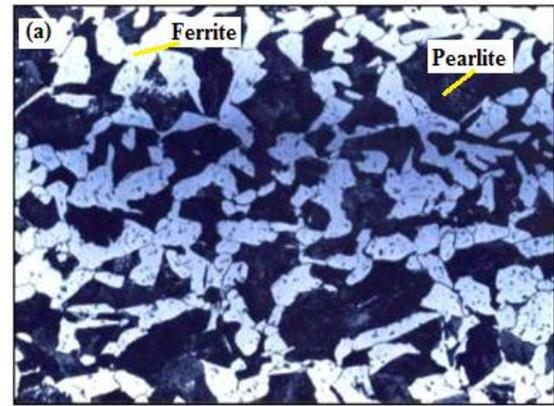
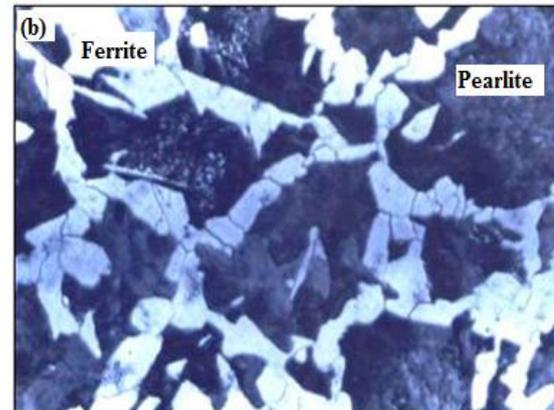
Fig. 4. Micrography of untreated steels: (a) and (c) : AISI 1038; (b) and (d): AISI 1045

The structure of the untreated pins is feritoperlitic (hypo-eutectoid) cellular (fig. 4a and 4b) characterized by low hardness (220HV for perlite and 80HV for ferrite).

Image analysis using the J image software in figure 4a and 4b, gives us the figure 4c and 4d images and the proportion of ferrite and pearlite.

The loss in mass of untreated AISI 1038 pins is greater than that of untreated AISI 1045 pins, because the area proportion ferrite of AISI 1038 (34.17%) is greater than that of AISI 1045 (24.5%) and the area proportion pearlite of AISI 1045 (75.5%) is higher than that of AISI 1038 steel (65.82%), and it is well known that pearlite is harder than ferrite. This means that AISI 1045 is harder than AISI 1038 steel.

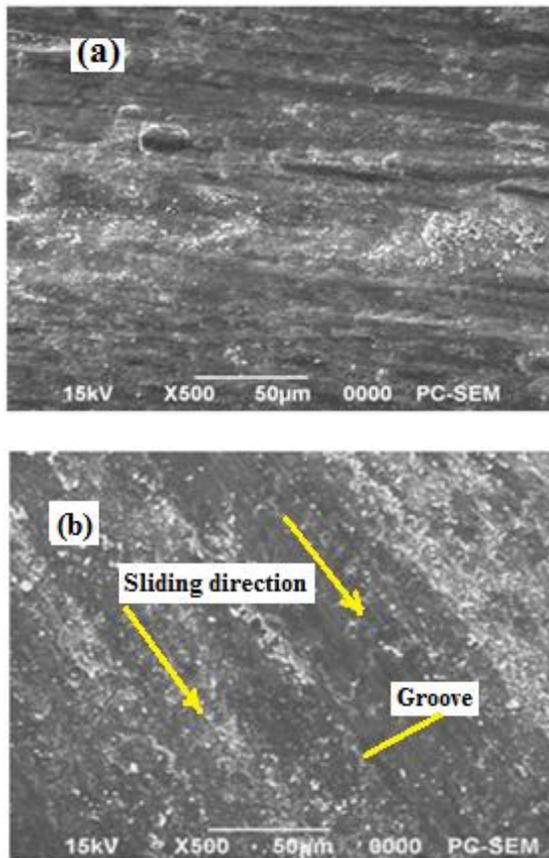
Fig. 5. Worn pin surfaces: (a) AISI 1038 untreated; (b) AISI 1045 untreated ($P = 20\text{N}$)

For the untreated pin, at the applied load 20N, the worn track (fig. 5) exhibits areas of friction giving the impression of plastic deformation and plowing of rubbed surfaces with a small adhesion (fig. 5a).

The grooves are plowed parallel to the direction of movement of the asperities (fig. 5b), particles distributed along the wear track. Wear is produced by the hard asperities of the contact surface of the disc on the contact surface of the pin (abrasive wear with two bodies).

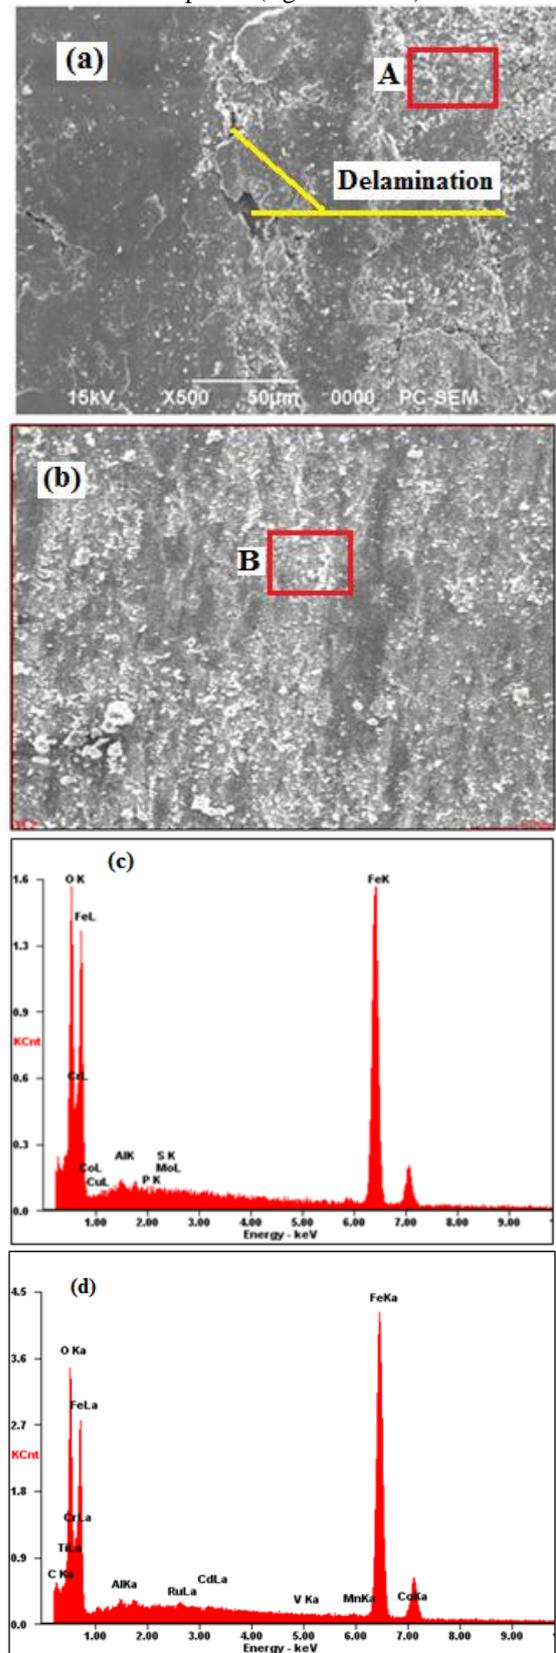
Fig. 6. Worn surfaces of untreated pins: (a) AISI 1038; (b) AISI 1045; (c) EDS spectrum of zone A in fig. 6a; (d) EDS spectrum associated with zone B in fig. 6b, $P = 40\text{N}$

At high load, adhesion, delamination and oxidation mechanisms have been observed. Significant damage is noticed on the worn surface (fig. 6.b). The main characteristics of the damage are delamination and severe plastic deformation and chipping of debris. This debris oxidizes, becomes hard and abrasive, and forms the third body. A protective oxide layer covers the majority of the contact surface of the pins and reduces the rate of wear.

The oxidative mechanism is confirmed by the associated EDS spectra (fig. 6c and 6d).

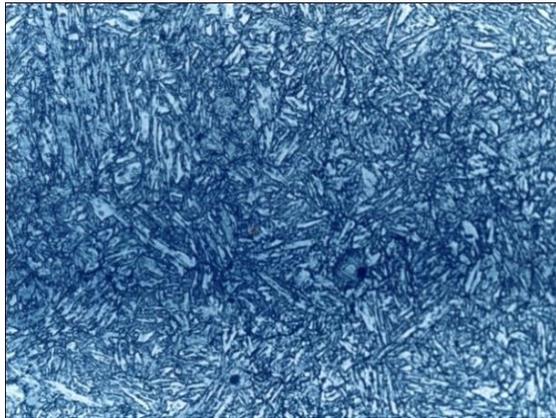
Fig. 7. Microstructure of AISI 1045 steel after quenching at 830 °C (x500)

Figure 7 is the microstructure of AISI 1045 steel after quenching, it is an elongated phase in flattened shape (needles or slats), characterized by great hardness and brittleness with distortions deformations produced during martensitic transformation. It is then necessary to follow the quenching by a tempering.

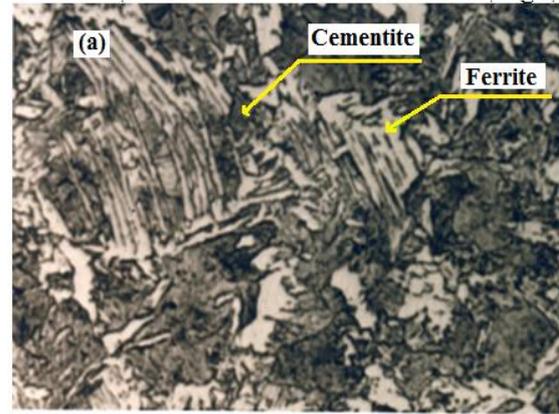
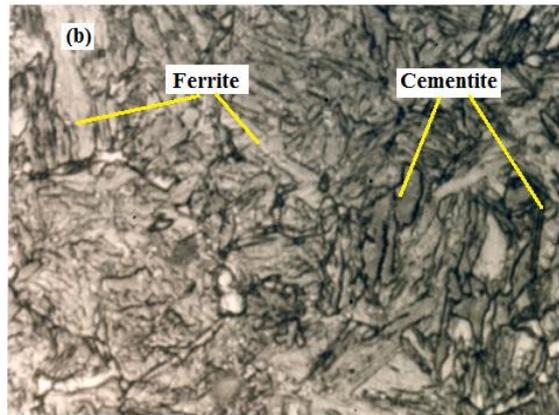
Fig. 8. Microstructure of steels after tempering: (a) AISI 1038 of hardness 30HRC; (b) AISI 1045 with hardness 35HRC (x900)

After the application of tempering on AISI 1038 and AISI 1045 steels at 500 °C, the microstructure will return to its stable state, that is to say (ferrite α + Fe_3C) which influences the hardness of the steel. It is clear that the microscopic observations show the presence of a high proportion of lamellar perlite characterized by long lamellae (fig. 8a). Figure 8b shows the microstructure of AISI 1045 steel after quenching and tempering at 500 °C. We can give the same previous interpretation except that the perlite lamellas are very diverse in their orientations and shorter than the lamellae of AISI 1038, this is why the hardness of AISI 1045 steel increases and resists wear better than AISI 1038 steel.

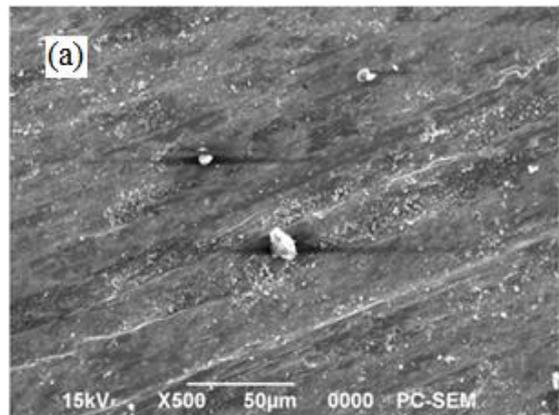
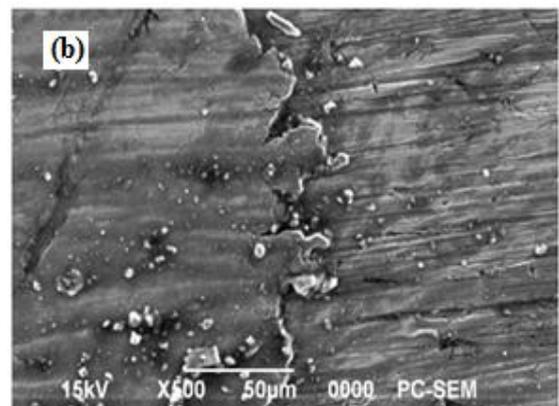
Fig. 9. Worn pin surfaces: (a) AISI 1038; (b) AISI 1045, P = 20N

The SEM observations made it possible to identify the typical characteristics of damage in the worn surfaces according to the normal load and the hardness of the pins. For the pin of high hardness, at an applied load of 20 N, the worn surface shows a smooth surface with signs of plowing and small plastic deformations (fig. 9a). In addition, resulting fine particles were observed on the generated micro-grooves. Tearing of the material (rupture of the junction) and shearing of the wear debris observed from the roughness of the disc surface on the pin surface (fig. 9b). As the hardness increases, the junctions formed become very small and the traces of adhesion decrease, we can distinguish a fineness of adhesion.

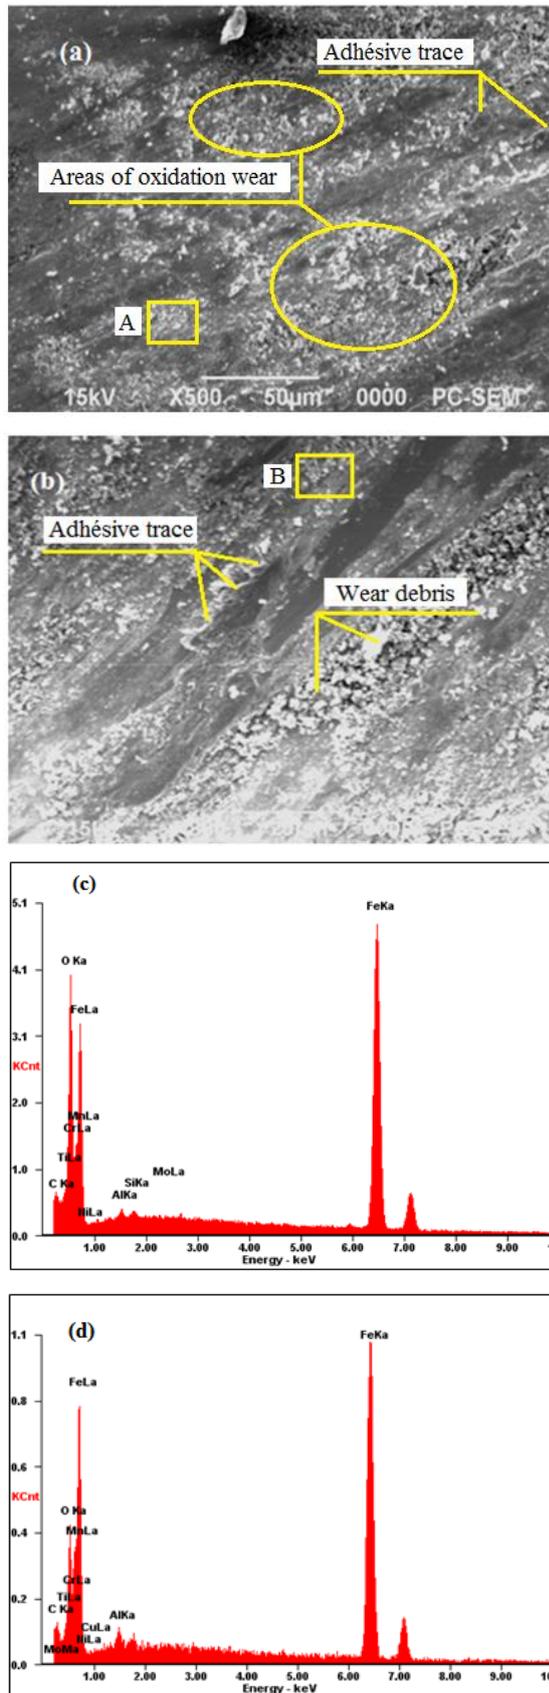
Fig. 10. Worn surfaces of treated pins:
 (a) AISI 1038; (b) AISI 1045; (c) EDS spectrum of zone A in fig. 10a; (d) EDS spectrum of zone B in fig. 10b, N = 40N

As the load increases to 40 N, an oxide layer develops and covers the surface of the pin (fig. 10a and 10b), the type of wear developed is oxidative (oxidative wear) with adhesive traces. This oxide film plays a protective role and considerably reduces wear [25]. The grooves are interrupted and isolated (fig. 10b), implying the presence of hard particles produced between the surfaces during friction and causing abrasive wear to three bodies. In addition, we also note the existence of adhesive traces.
