A DEVICE FOR MEASURING CONVEYOR BELT THICKNESS AND FOR EVALUATING THE CHANGES IN BELT TRANSVERSE AND LONGITUDINAL PROFILE

Wrocław University of Science and Technology

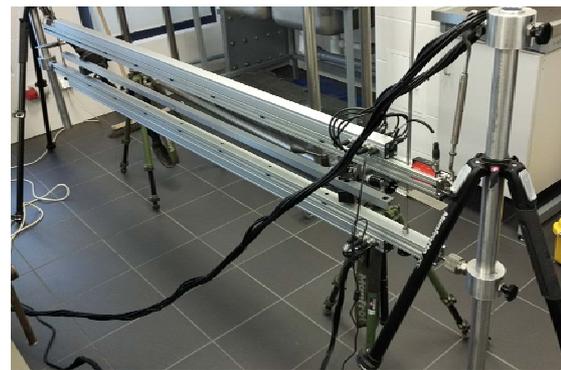
Fig. 2. The DiagBeltSonic device for measuring conveyor belt thickness

transverse and longitudinal profile was developed at the Machine Systems Division, Wrocław University of Science and Technology. The device, shown in Fig. 1 and in Fig. 2, comprises two measuring bars placed in parallel one above another. The bars comprise ultrasonic sensors. Both bars are positioned on two adjustable racks. The upper measuring bar has a laser distance sensor.

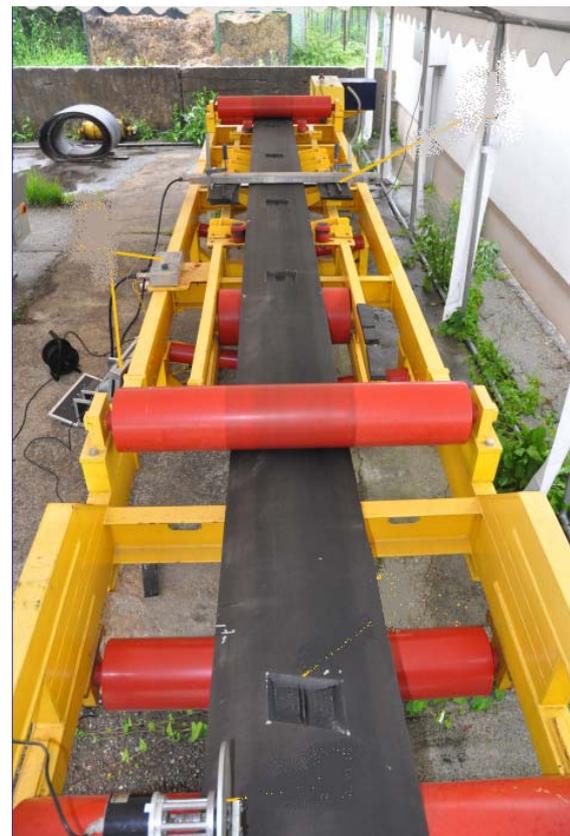
Fig. 6. General view of the diagnostics of conveyor belts

The device for measuring belt thickness was tested in laboratory conditions on a test conveyor (Fig. 5,6). The test conveyor comprised the same elements as the conveyors operated in mining conditions, i.e. a supporting structure with top and bottom idler sets, drive and tail pulleys and belt tensioning mechanism. Both textile and steel-cord belts can be installed on the test setup. The setup allows developing and testing methods for the evaluation of conveyor belt condition which are based on image analysis and the use of magnetic heads. The speed is regulated in the whole speed range encountered in Polish mining industry, i.e. from 0 m/s to 7.5 m/s.

The test stand was paired with the St 1600 steel-cord belt, 400 mm in width and wrapped around the drive and tail pulleys of 400 mm in diameter. The length of the belting in the loop was 16400 mm. Although the dimensions of the test conveyor do not reflect the dimensions of an actual conveyor, it was possible to recreate some of the actual operating conditions, including:
