EFFECTIVENESS OF DIAGNOSING DAMAGE TO AN INDUSTRIAL PUMP ROTOR BY ANALYSING ITS VIBRATIONS

Janusz ZACHWIEJA

University of Technology and Life Sciences in Bydgoszcz, Faculty of Mechanical Engineering,
Bydgoszcz janusz.zachwieja@utp.edu.pl

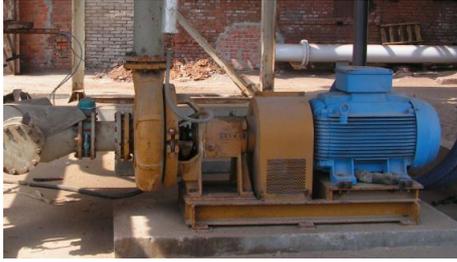
Fig. 1. A view of a Worman pump connected to a pipeline

Fig. 1 presents a Worman pump connected to pipelines. Measurements of vibrations conducted for diagnostic purposes have indicated the presence of high values of vibration parameter amplitudes, both of the pump and the pumping pipeline connected thereto. This condition often makes the pipeline connector crack, causing destabilisation of the production process and posing a threat to the environment.

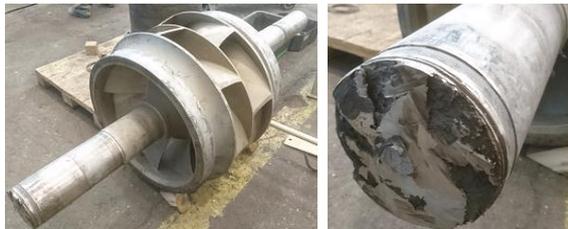
An example of damage of this type is a crack of a rotor shaft of a large industrial pump. The shaft got twisted (Fig. 5) in a section located close to the bearing on the side opposite to the drive. This occurred two months after the bearings had been replaced. Renovation of the pump was imposed by the observed increase of the rotor vibration parameter amplitude of an unknown reason.

Fig. 5. A view of the rotor and section in the crack area
