TECHNICAL DIAGNOSTICS OF HYDROPOWER TURBINE USING MODERN MEASUREMENT TECHNIQUES

Grzegorz ŻYWICA¹, Maciej KANIECKI²

Summary

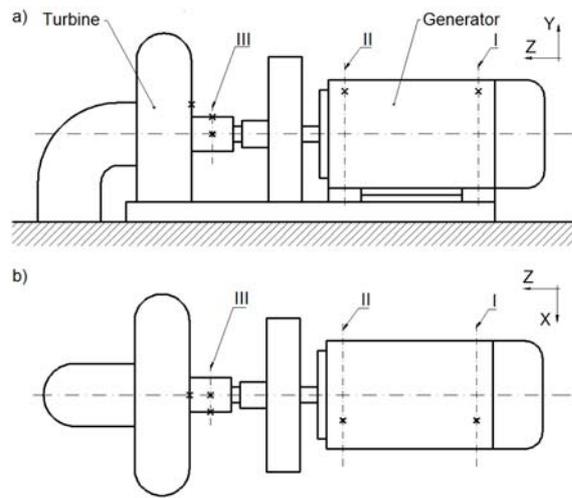
Fig. 2. Turbine set scheme with measuring points (a – side view, b – top view).

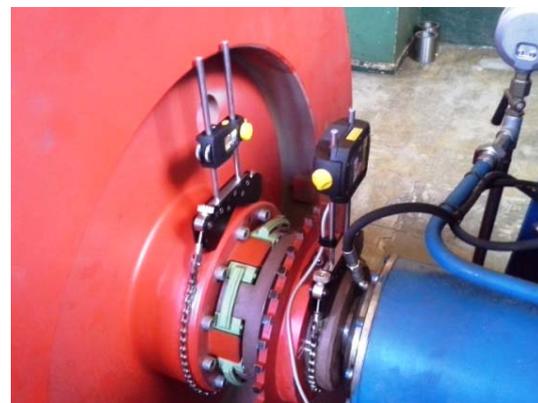
Fig. 7. Laser encoder with reflector used during shaft alignment.

The shaft alignment check revealed the exceedance of limit values in the vertical plane. The height difference between two coupling parts was

only around 0.18 mm, meaning that a change in the heights of front and rear generator's terminals must be applied. These heights were adjusted by 0.25 mm and 0.38 mm, respectively (Fig. 8). Other values were within the recommended tolerances.
